CASE HISTORY #1

APPLICATION: Optical Alignment, Cylinder to Crosshead Guide Including perpendicular relationship between crosshead centerline and bed section and distance piece flange face mating surfaces.

EQUIPMENT: Dresser-Clark 2-CLBA-1 Reciprocating Compressor

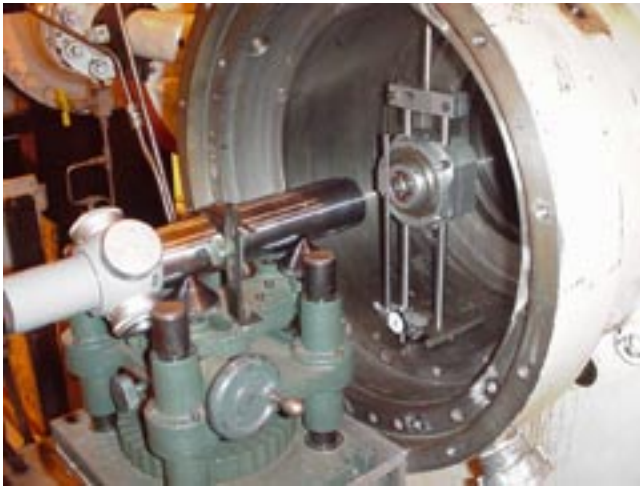
Optical Line Scope Mounted on Cylinder

The following photographs illustrate the optical line scope and target set-up used for this alignment check. The connecting rods were removed exposing the whole crosshead guide for measurement.

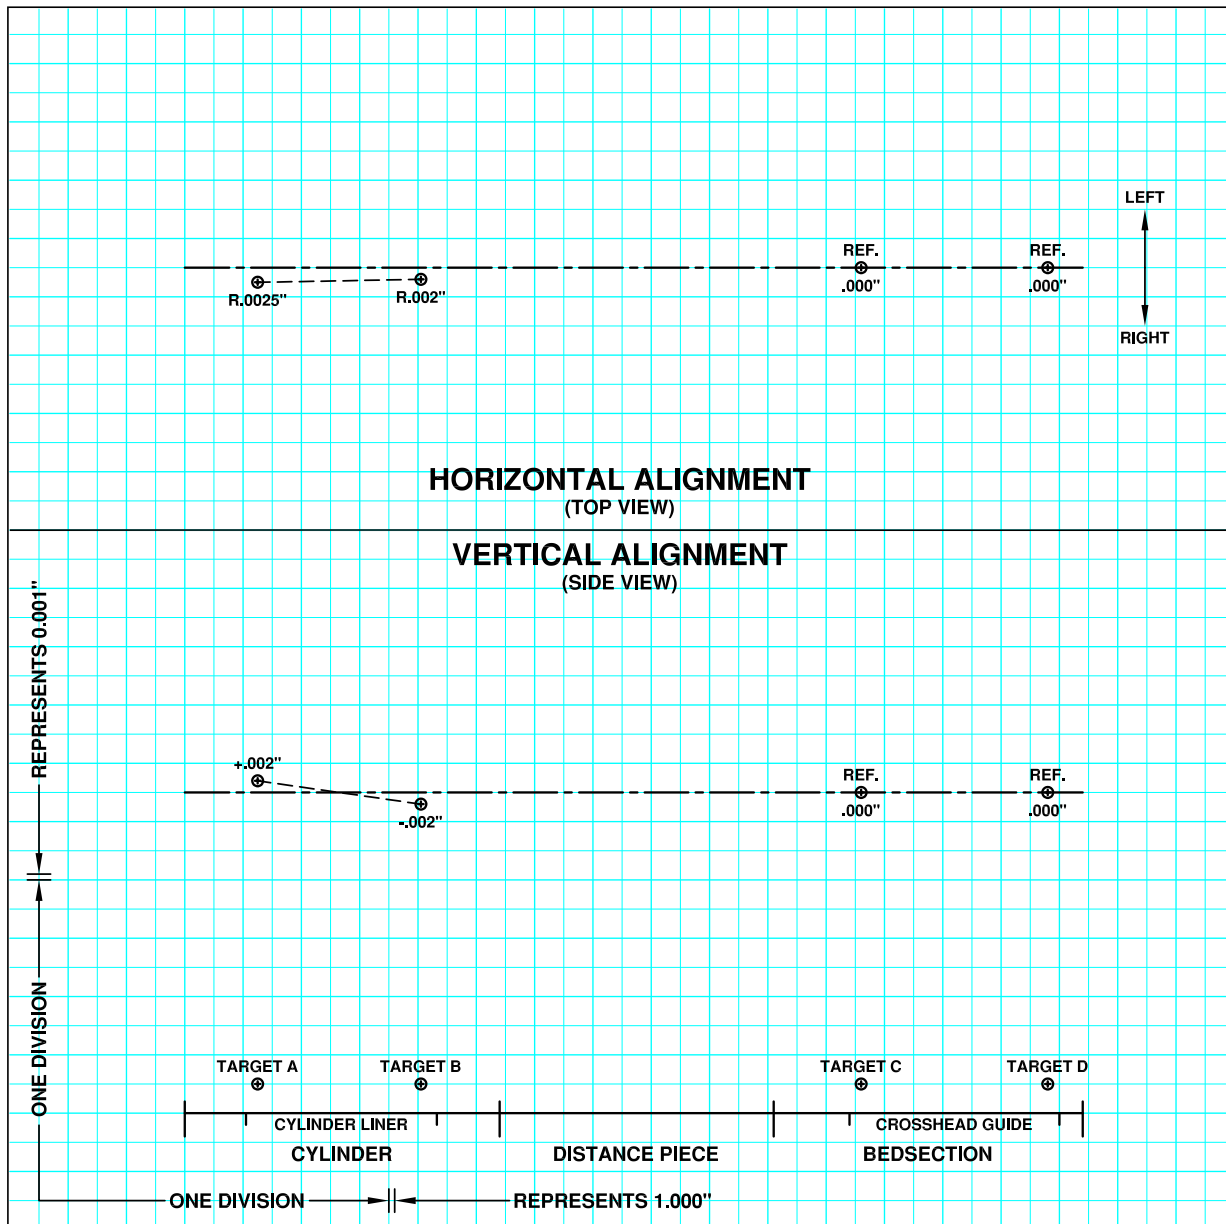
Reference Crosshead crank End	Reference Corshead Cylinder End	Vertical Cylinder Inner	Vertical Cylinder Outer	Horizontal Cylinder	Horizontal Cylinder
1988, Cylinder #1	.000"	.000"	-.0165"	-.018"	R .004"	R .004"
1988, Cylinder #2	.000"	.000"	-.011"	-.0145"	R .0085"	R.0085"
1995, Cylinder #1	.000"	.000"	+.0275"	+.0305"	L .004"	L .006"
1995, Cylinder #2	.			Data Not Recorded		
2002, Cylinder #1	.000"	.000"	-.001"	-.0035"	R .002"	R .0025"
2002, Cylinder #2	.000"	.000"	-.0095"	-.0095"	L .0075"	L .010"

The following alignment drawings show the 2002 final alignment position of the new cylinders.
